BAYERISCHE MOTOREN WERKE  
AKTIENGESELLSCHAFT

Rundschreiben der Abteilung Kundendienst und Teile

Motorcycles: Group Rear Wheel Drive No. 1/62 (183) engl.

Drive shafts BMW R 25/3 - R 26 - R 27

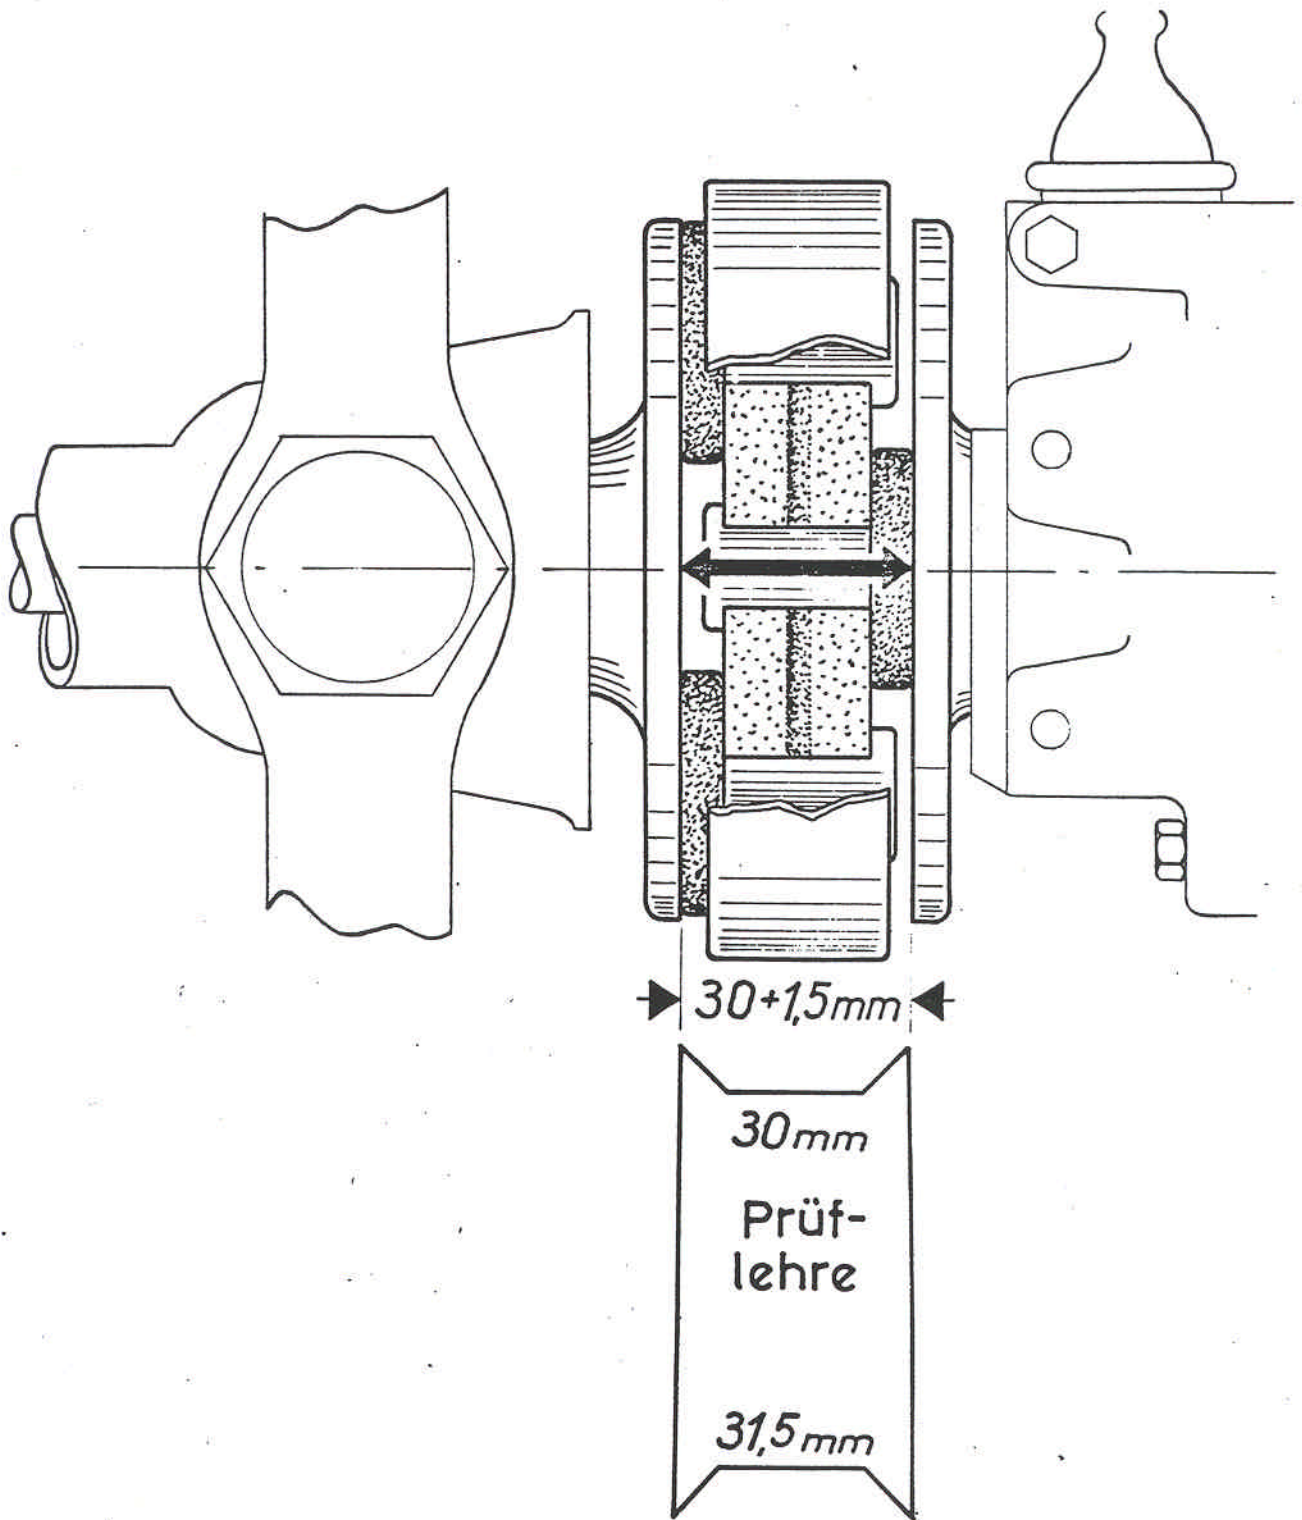
Rad (183)

Occasionally we are receiving reports concerning drive shaft breakages on the motorcycle models referred to above.

the distance between the driving flange of the transmission and the mating flange of the drive shaft, measured with the drive shaft in horizontal position, amounts to 30 + 1.5 mm. (1.2" + .06").

To check and adjust this distance we suggest that a checking gauge be made of a 3-4 mm. (.12" to .16") thick flat iron as per enclosed drawing. To prevent further damages, the above mentioned distance must, whenever a repair work has been carried out on the bevel drive or on the drive shaft itself, absolutely be checked and, if necessary, adjusted, loading the motorcycle for this so the drive shaft is in horizontal position and that the two flanges are thus parallel.

The necessary corrections, if any, should be performed, on the R 25/3 type, by pressing the coupling flange up or downwards, on the models R 26 and R 27 by means of spacing washers (shims).
